This profile summarizes the characteristics of the watersheds in District 10; provides an overview of flooding, erosion, and water quality problems; and discusses past, current, and upcoming solutions.

Watershed Protection District 10 Profile

January 1, 2015

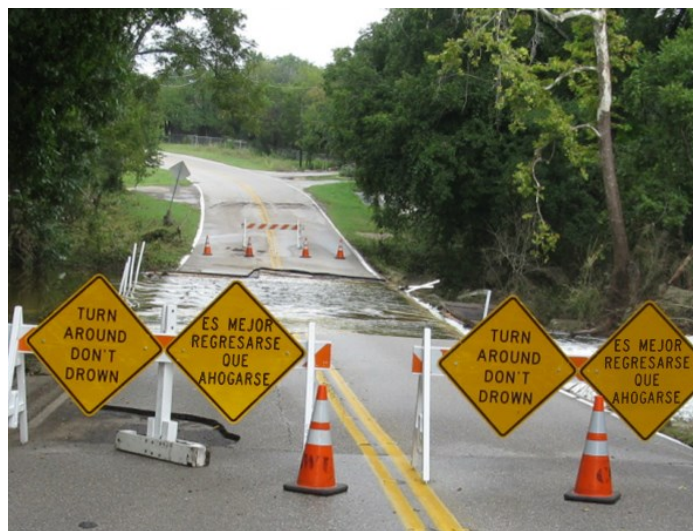
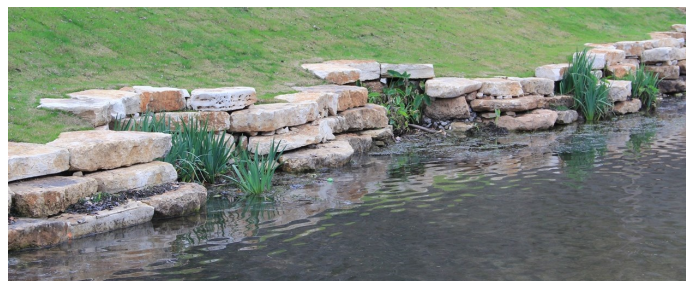
Photos of a low water crossing at Spicewood Springs Road after Tropical Storm Hermine (above) and a natural rock bulkhead along Lake Austin (below).

- **Programs:** Given the numerous low water crossings in this district, the Flood Early Warning System (FEWS) is an important program. Designed to protect citizens from potential harm due to flash flooding, the system consists of gauges throughout the city wirelessly reporting data back to a central station for management and decision-making. Based on this data, FEWS engineers make predictions on where flooding will occur, which the Office of Emergency Management staff uses to direct emergency responders and notify the public. For example, staff can remotely activate flashing warning signs or direct field personnel to place “Turn Around Don’t Drown” barricades, as shown in the photo below.

- **Regulations:** With the first watershed protection ordinances for the Lake Austin watershed adopted in the late 1970s, regulations have been a key strategy in this district for over 35 years. Since over 90 percent of the district has either been built out or preserved as open space, regulations will mostly apply to redevelopment projects moving forward, which are required to build water quality ponds and protect against additional erosion and flooding. In addition, staff recently revised the code to implement recommendations of the Lake Austin Task Force related to docks, bulkheads, trams, and a zoning overlay.
